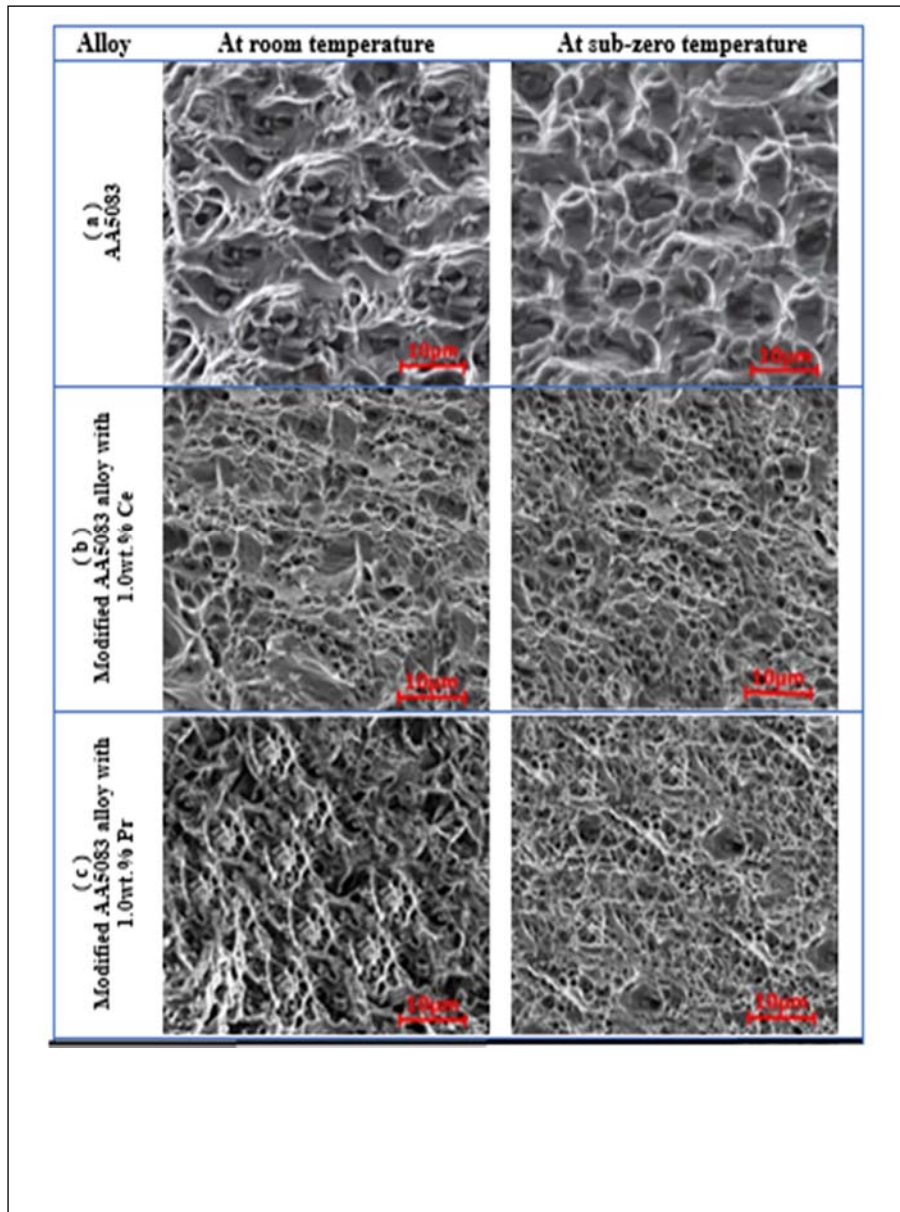
FIG. 4. PV-SEM images fractographs of fracture surfaces of tested samples after impact tests at room temperature and sub-zero temperature (a) AA5083 (b) Modified AA5083 alloys
