## Evaluation of areas susceptible to failure in hot-pressed ceramic crowns

**Abstract:** Fracture of ceramic materials has been one of the most frequently reported complications for all-ceramic restorations. The aim of the study was to analyze the fracture features of hot-pressed ceramic crowns in order to evaluate areas susceptible to crack initiation and crack propagation correlated with stress areas. The crowns were inspected visually to determine the shape and orientation of the crack. The fracture surfaces of each restoration were documented with photographs of fractographic features and were examined using scanning electron microscopy. The starting point and crack propagation were determined using standard fractographic methods. A systematic approach to failure analysis is important in order to interpret failure data for all categories of ceramic restorations available today. Further studies of clinically relevant fracture testing and other experimental simulation methods are necessary in order to suggest different strategies for restoration design, and tooth preparation.

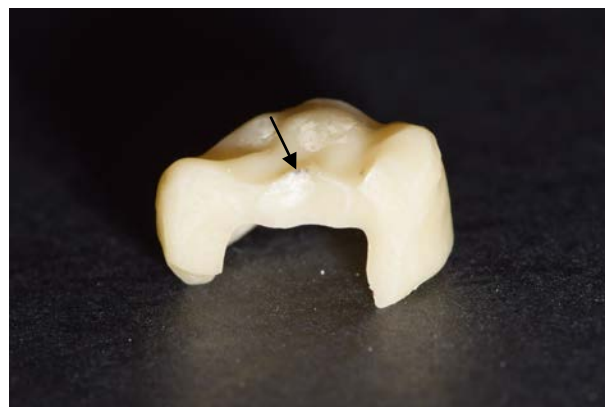
Fig. 1. Fracture surface of a pressed ceramic crown specimen exposing fracture origin on the occlusal loading point and the fractographic map.

The exact origin of the crack is located at the loading area (generated during experimental tests) and from there a critical crack started and propagated along the axial and occlusal walls until fracturing the whole crown into two parts, used for the fractographic analysis (Fig. 1, 4).

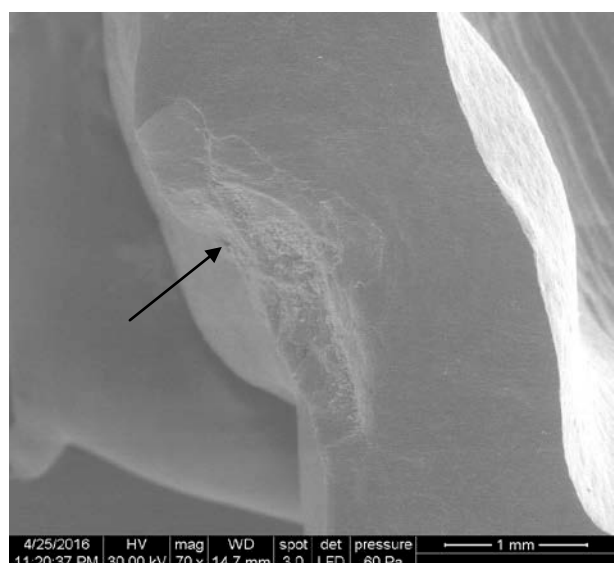
Fig. 2. Scanning electron microscopy images of one fragment of a pressed ceramic crown (black arrow indicates the loading point).

Using the SEM, the concave orientation of the arrest lines as well as the presence of many fine twist hackle emanating from the arrest lines indicated that the damage started on the occlusal loading surface of the crown (Fig. 2, 3, 5, 6).
