Failure behavior of bilayered all-ceramic crowns

Abstract: Based on clinical long-term data bilayered single crowns can be considered as a reliable and promising treatment option that can be recommended in the posterior region. Veneer chipping and zirconia frameworks fractures are critical issues in all-ceramic restorations. The objective of this study was to assess the failure behavior of bilayered all-ceramic molar crowns, evidenced by different type of fractures. Experiments were conducted on a right first maxillary molar. Bilayered all-ceramic crowns were obtained with a 0.5 mm thick zirconia milled framework and veneered with hot-pressed ceramics. The specimens were tested at compressive load until failure. The typical macroscopic crack pattern of all samples showed that crack propagation resulted in more broken pieces with sharp edges. Ceramic materials show considerable variation in strength due to their extreme sensitivity to cracks. Understanding the fracture behavior of dental ceramics and its relation to different materials and restorations is important from a clinical point of view.

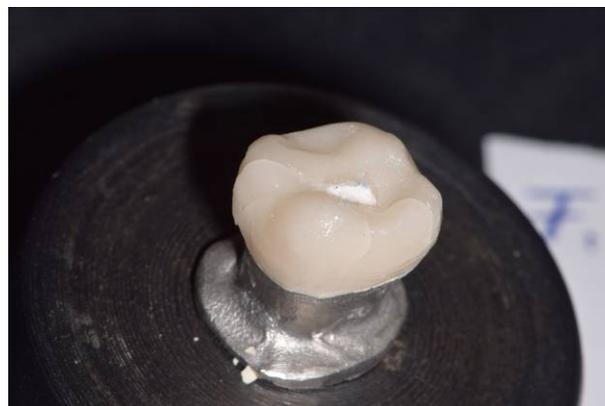
Fig. 2. Fracture pattern of sample 1 – type 4 - with fracture of the framework and veneering material.

pattern of all samples showed that crack propagation resulted in more broken pieces with sharp edges (Fig. 2, 4, 6). A correlation between fracture load and number of fractured pieces of the specimens was no observed (Fig. 3, 5, 7).

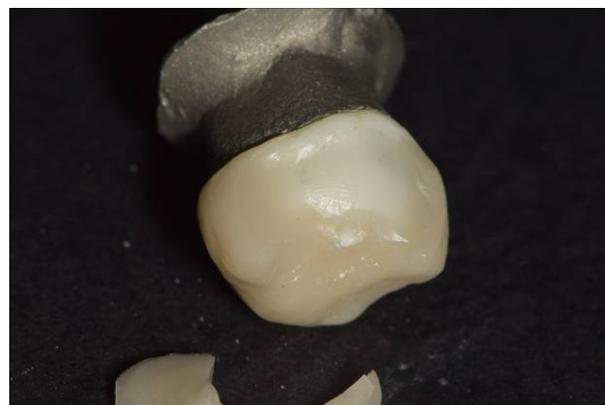
Fig. 4. Fracture pattern of sample 3 – type 3 – fracture of the veneering material, exposing the framework.

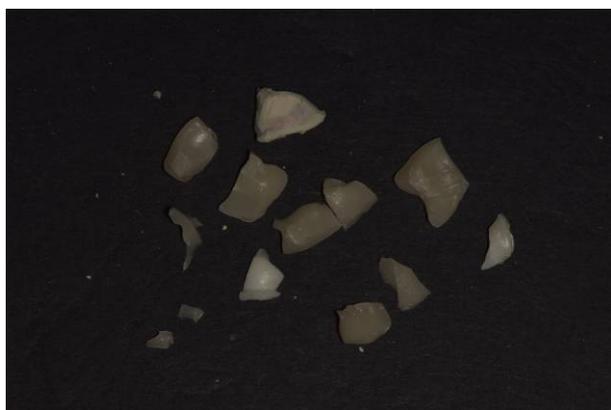
Fig. 6. Fracture pattern of sample 1 – type 4 - with fracture of the framework and veneering material in multiple pieces.
