Fracture resistance of different integral ceramic restorations

CRISTINA SAVENCU¹, LILIANA POROJAN¹, ADRIAN BOLOȘ², LUCIAN RUSU³, CRISTINA BORTUN¹

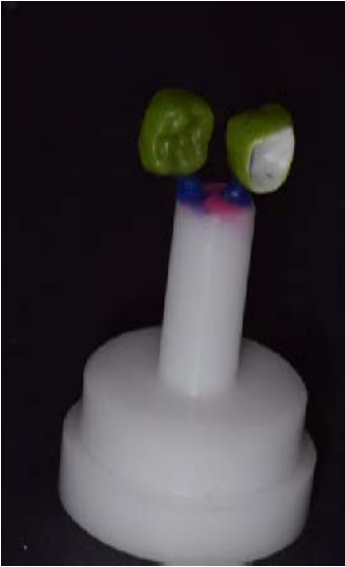
Fig. 1. Wax pattern over zirconia core prepared to be invested.

Resin patterns were invested in a specific phosphate-bonded investment mass. After burning the patterns, a glass-ceramic (Cergo Kiss, DeguDent, Hanau, Germany) was pressed in the pre-heated mold at 980° C, 4.5 bar, for 20 min. After the cooling, mold is divested, the crown is adapted, finished and glazed. Zirconia frameworks, both with uniform thickness and anatomically-reduced, were milled from pre-sintered zirconia blocks, 25% larger than the original size, automatically calculated by CAD system, for compensate firing shrinkage. After milling, copings were sintered at 1350°C for 7 hours in a specific furnace. After sintering and adaptation, frameworks had been sandblasted with alumina (110-125UM, at 3 bar, 45 angle) and cleaned with a steam cleaner. A wax-pattern was shaped using a mold over the copings, in order to keep the same morphology and dimensions for the final crowns (Fig.1)

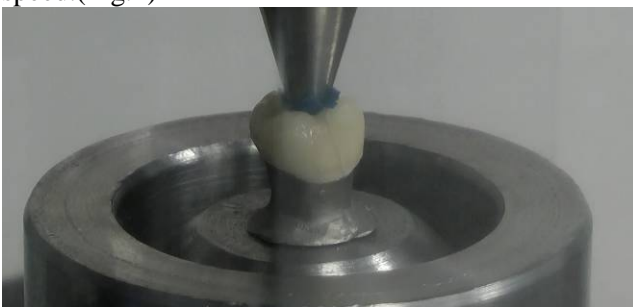
Fig. 2. Probe under loading

Probes were attached at 0 degrees to the long axis of the crown. The force was expressed through a stainless steel, 15 cm long with a round end of 6 mm diameter stylus. To prevent the load dispersion a 0.2 mm rubber dam was applied between tip of the stylus and ceramic surface. The force was applied on the occlusal surface, the load was increased from 0 to the fracture point, with 2 mm/min crosshead speed.(Fig.2)

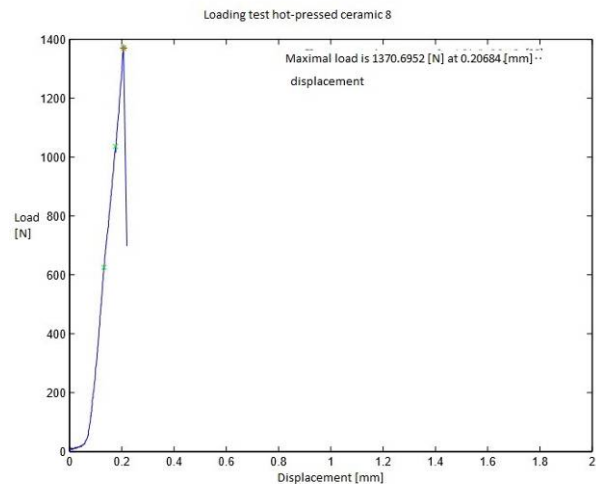
Fig. 3. Load test hot-pressed ceramic

Significantly lower fracture resistance was observed in the first group of specimens - hot-pressed ceramics, with a mean of 1683 N (Fig. 3).

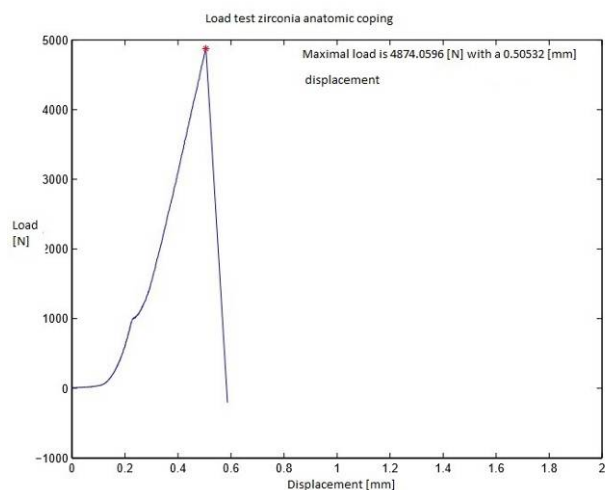
Fig. 5. Load test anatomic-reduced zirconia framework.

Best results were obtained for zirconia anatomic-design core group and uniform thickness veneer porcelain, with a mean value of the braking-force of 4659 N (Fig.5).

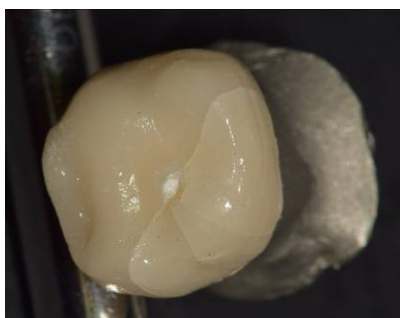
Fig. 6. Fracture initiation point and extension.

The fracture initiation point was at the load-application point, and extended to the axial walls. (Fig.6)
