The impact of the building structure, accumulation and distributive infrastructure of the “Ujmani” reservoir in the effectiveness of catchments

Key-words: -Ujamnai, accumulation, main canal, irrigation, hydro-system. agriculture, industry

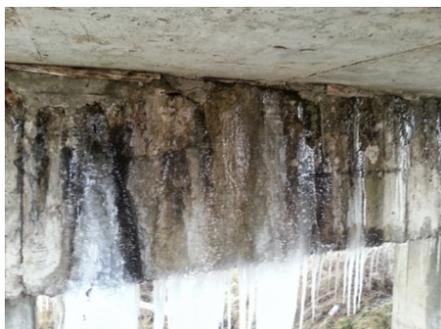
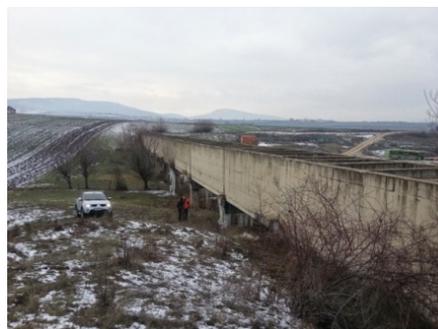
Distributor canal – almost 30 years have passed, since the construction of the distributive canals, where their current situation consists of a huge loss of Water, due to the aging of the amortization structure. Physical damages have caused losses, where we see large cracks, which are measured up to 0.50m. The main infrastructural objects of the canal, such as, tunnels and siphons have not been rehabilitated and the damages can be easily seen in these structures, which are done because of the aging, as well as, physical injuries, which represent a potential risk, in the future, for the normal functioning of the canal [5]. The maintenance of buildings, in emergency cases, is not at the right level. In some parts, the erosion soil is easily seen. As a result, the final point of the canal reaches up to 60%, of which half are due to the mismanagement of Water (this includes the issuance of larger quantities of Water than needed) and the other half are due to the factors that we have mentioned above. Starting from the open canal with a trapeze shape, the canal passes through the U-Profile cutting rectangular, which as a holder starts with a distance of 12.00m in frame. The walls of the canal, on the upper side, are made of a reinforced concrete with 0.30x0.30m dimensions, at a distance of 2.80m. The walls and floor are made of reinforced concrete with a thickness level $t = 40.00\text{cm}$, the filling of the trench with Water, depends on the issuance and spending, as well as, the needs of hydro-meteorological conditions. You can easily observe the surface degradation, from the inside, as well as, minor damages in the wall, hanging at a Water level. This level reaches the Water with low temperatures, due to freezing, the concrete structure gets damaged and, with time, it may face bigger damages with larger consequences (Foto 2&3). Due to freezing and external Water flow, the pillar holders may also get damaged. The damages are evident and, mostly, in the protective layer of armor, where we can easily notice a reinforced degradation [6].

Foto 2&3. The canal condition before the repairmen

In order of preventing the risks for the future generations, the old infrastructure needs the first repair. Repairs on aqueducts, canals with the form of trapeze, joints and drainage canals, have given positive impacts on the water supply of the request of the economic operators. Therefore, the repairs made within time, result positively. The water quality, in the storage, is considered as good, but during the transmission, throughout the canals, we were able to find pollution, which, are mostly caused from the human factor and the other ones from the rainfall and

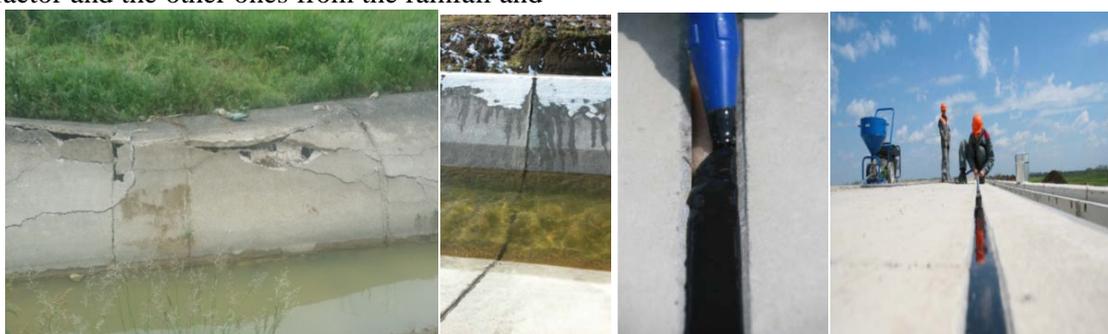
snow. The greatest losses are in the distributive canals. These structures are built of concrete. The length of the open canals, aqueducts, and cross-overs from the starting point of the canal, are approximately 24500m. The length of the canal with a trapeze shape is 18913.85m, where, up to this moment, 80% have been rehabilitated, of which the failure of modern material technology is easily noted, specifically in the material joints (see picture 4,5,6&7).

Pictures 4, 5,6&7. Current status of a partially restored canal and the rehabilitacion canal with the Fuga materials

Pictures show the rehabilitation of the canals, but the failure of the jonit materials can be easily seen. According to the research done, we have found out that the material used is of new technology. We have found the adequate materials for these issues, such as, Fix-O-Flex – the German manufacturer. With the introduction of this material, the biggest bulk of flows is eliminated. Other facilities are in poor conditions, where we can find Water loss and in
